Technical Report CHL-98-22
July 1998

Three-Dimensional Breakwater Stability Tests at Vale de Cavaleiros, Cape Verde

by Ernest R. Smith, Jeffrey A. Melby

Prepared for Joint Venture RRI-BCEOM

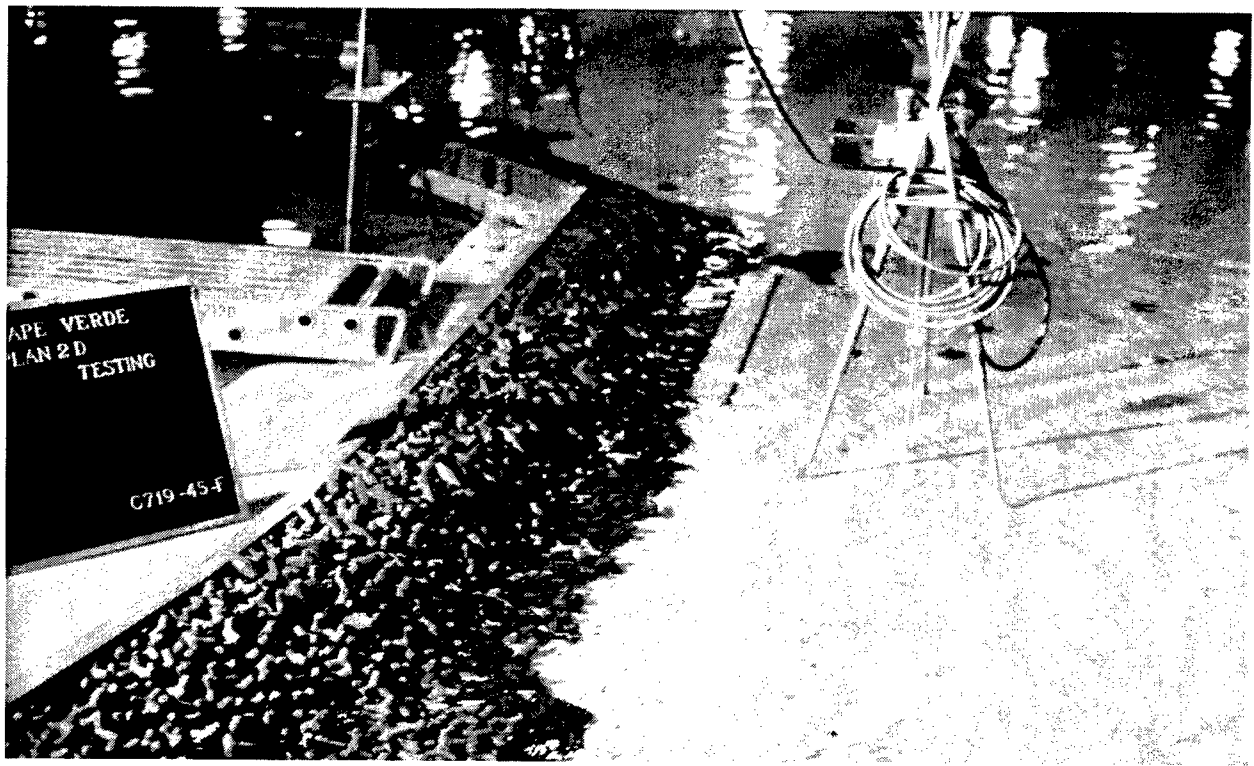
Photo A45. View from north of plan 2D breakwater trunk after testing with total sequence

units settled causing exposure of underlayer stone between Profiles 4 and 5 (Photos A45 and A46).
